Visual Building Inspection Report

Commissioned By: Sample Legal & Associates

Property Inspected: 14 Sample Street, Sydney

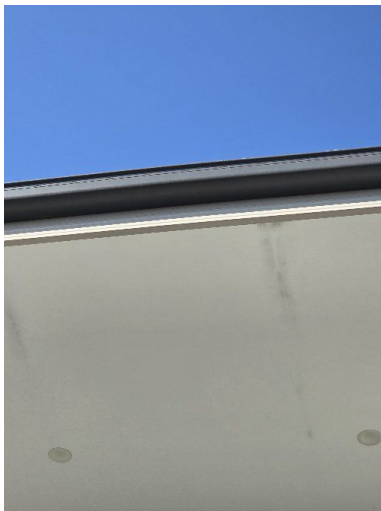
Eaves Type & Condition

The eaves are lined with fibre cement sheeting. The overall condition of the eaves lining is poor. Water damage/staining is present to the eaves linings.

Estimated cost: \$Note.

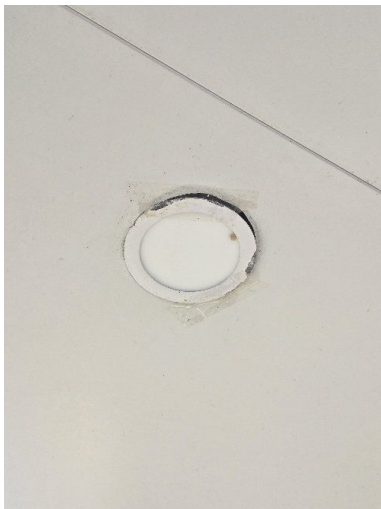
Deck

Water ingress through light fittings noted. Roofing low pitch for material used may result in water leaks to ceiling.

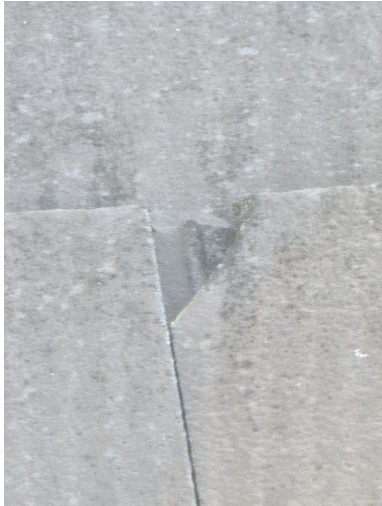
Condition in Detail:

The overall condition of the roof coverings is fair. A small number of cracked roof tiles were noted and should be replaced.

Estimated cost: \$200.

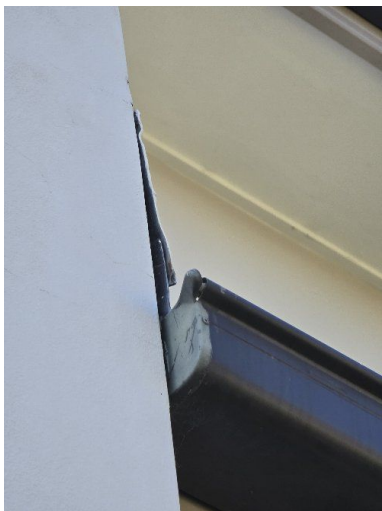
Flashings

Flashing material is of lead. The potential for water entry is present.

Estimated cost: \$400.

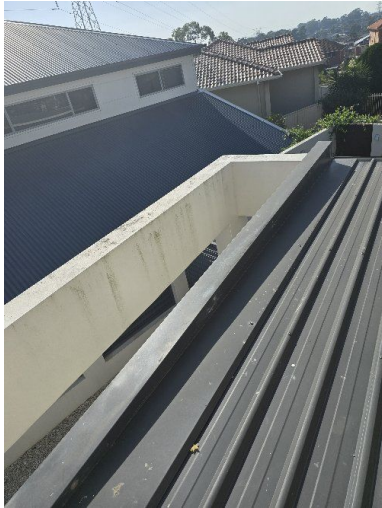
Skillion Roof A

The condition of the skillion roof covering is fair. The flashing is in poor condition and requires repair or replacement. Inadequate fixing to parapet capping.

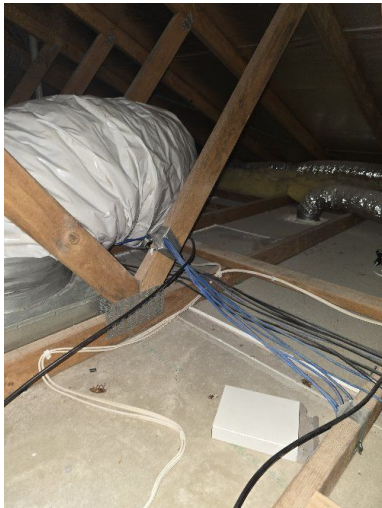
The insulation is out of place and should be re distributed correctly.

Estimated cost: \$600.

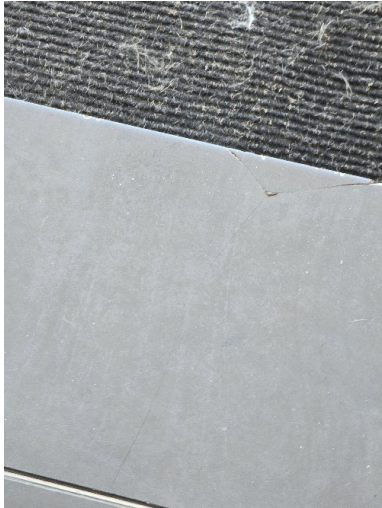
Entry/Foyer

The condition of the floors is generally fair. Cracking is evident to some floor tiles.

Estimated cost: \$200.

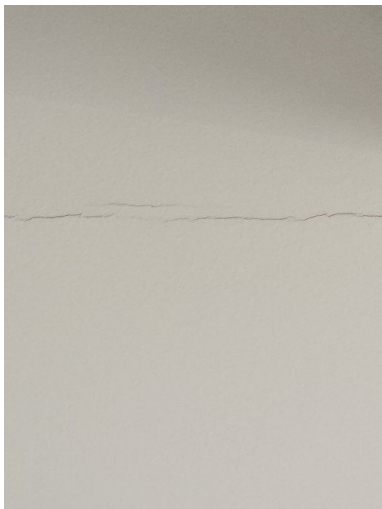
Ceiling Condition

The condition of the ceilings is generally fair. Minor settlement cracks were noted and is typical of this type of material. Crack opening width greater than $1.0\text{mm} < w < 5.0\text{mm}$. Periodic maintenance may be required.

Estimated cost: \$400.

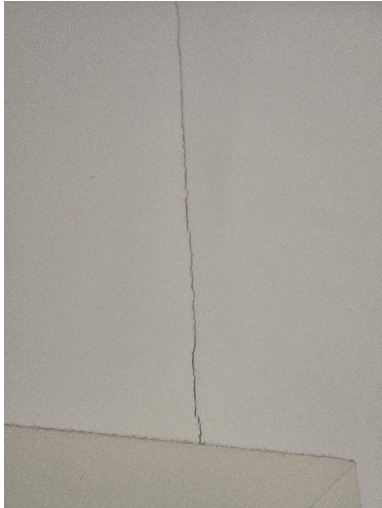
Walls Condition

The condition of the walls is generally fair. Minor settlement cracks in walls. Crack opening width greater than $1.0\text{mm} < w < 5.0\text{mm}$. Periodic maintenance may be required.

Estimated cost: \$400.

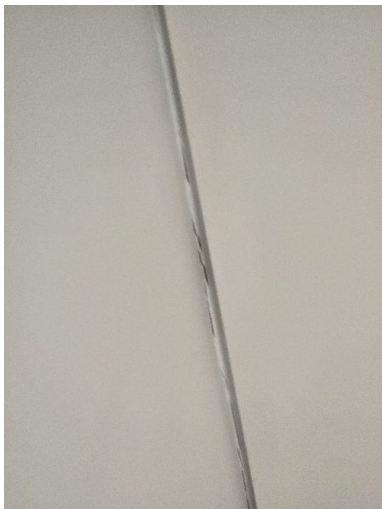
Dining Room

The condition of the ceilings is generally fair. Poor joint setting was noted to ceiling lining. Repairs are required to ceiling linings.

Estimated cost: \$300.

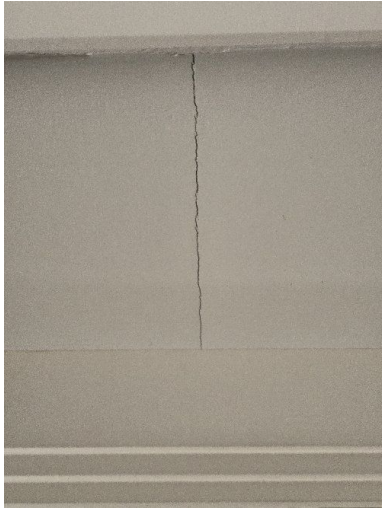
Walls Condition

The condition of the ceilings is generally fair. Poor joint setting was noted to ceiling lining. Repairs are required to ceiling linings.

The condition of the walls is generally fair. Minor settlement cracks in walls. Crack opening width greater than 1.0mm <math>w < 5.0\text{mm}</math>. Periodic maintenance may be required.

Estimated cost: \$300.

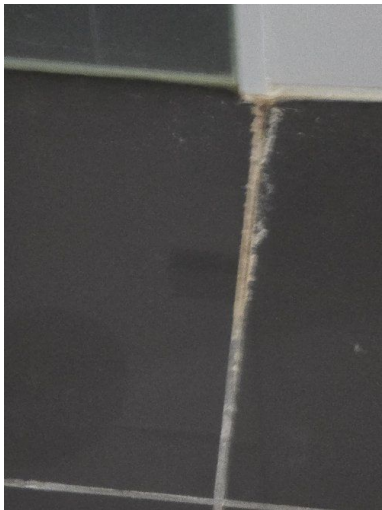
Ensuite Bathroom

The shower recess was tested and there was no visible water penetration to surrounding areas. **IMPORTANT NOTE:** This test may not reveal water leaks until the shower is put into constant use and surrounding areas monitored over a period of time. Silicone sealant has been applied to the interface of the floor and walls in the shower recess in an apparent attempt to prevent water penetration to surrounding areas. This method of repair can only be considered to be temporary.

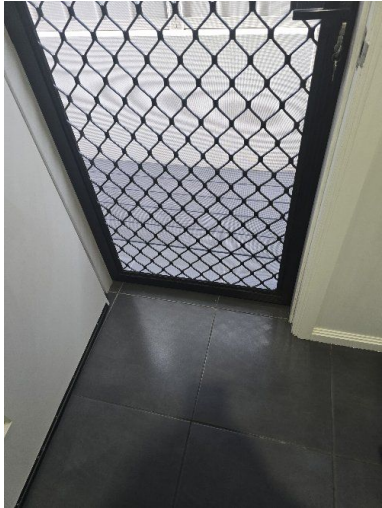
Laundry

The condition of the floors is generally fair. Inadequate stepdown to threshold resulting in potential water ingress.

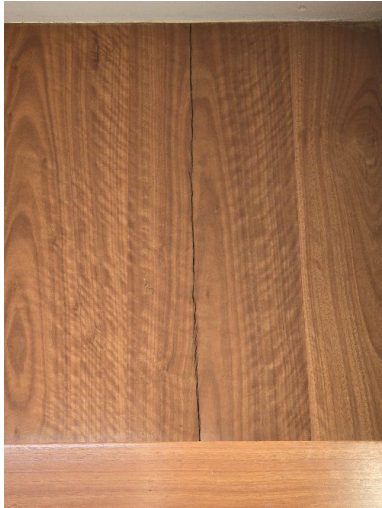
Stairs Internal

The stairs are constructed primarily from timber. The overall condition of the stairs is fair. Movement is evident to the stairs. This will require some minor maintenance.

Estimated cost: \$400.

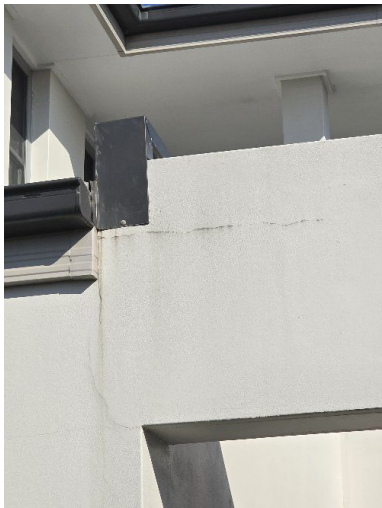
Rear elevation.

The condition of the walls is generally fair. Cracks are evident to brickwork or render. Visible evidence appears minor. Crack opening width greater than 1.0mm<w<5.0mm. The area(s) where cracked brickwork or render was noted is listed below.

Estimated cost: \$800.

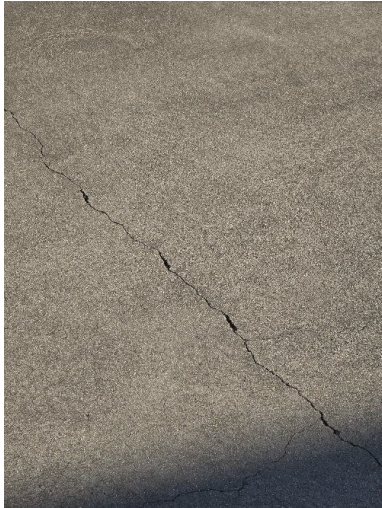
The concrete driveway stands in fair condition. The concrete driveway has some visible cracking that should be monitored for further movement.

Estimated cost: \$1800.

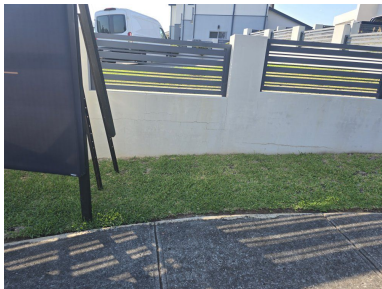
Fences & Gates

The fences are mainly constructed from metal. The fences are mainly constructed from brick. The fences are generally in fair condition and some repairs or maintenance is required. Repairs to fences are required. Minor cracking to masonry walls.

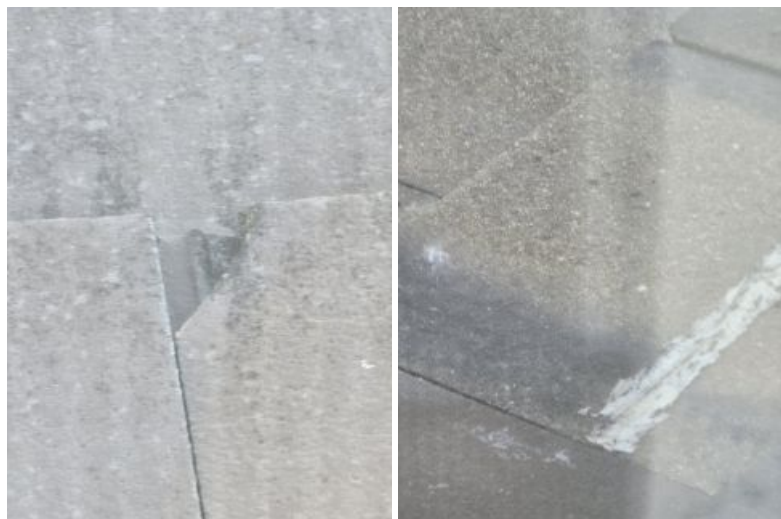
External Roof

Roof Style:	The roof is of pitched style construction.
Roof is covered with:	concrete tiles.
Roof Access Limitations:	The roofing materials were viewed from a distance only. It should be noted that when roofing cannot be inspected in detail, other associated aspects of the roofing are also often not inspected in detail. These may include items such as gutters, eaves, flashings, chimneys and other items that would require a detailed and close inspection of the roof surface.
Condition in Detail:	The overall condition of the roof coverings is fair. A small number of cracked roof tiles were noted and should be replaced.

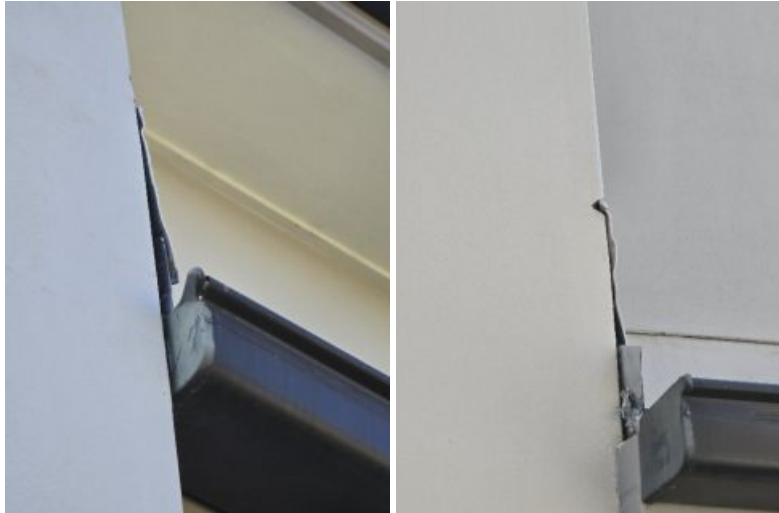
Flashings

Type and Condition	Flashing material is of lead. The potential for water entry is present.
--------------------	---

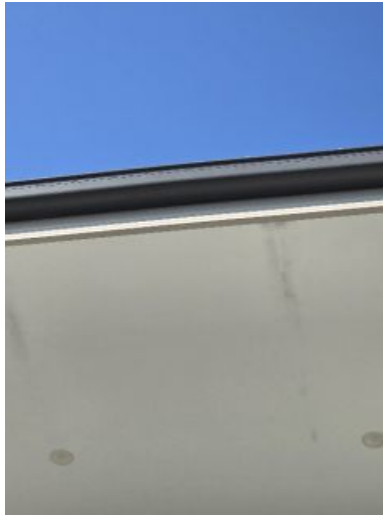
Eaves Type & Condition

The eaves are lined with fibre cement sheeting. The overall condition of the eaves lining is poor. Water damage/staining is present to the eaves linings.

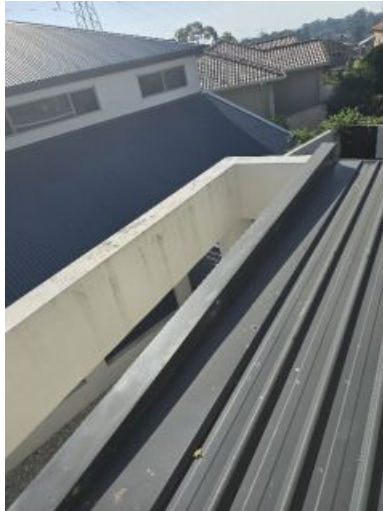
Skillion Roof Covering Status

The condition of the skillion roof covering is fair. The flashing is in poor condition and requires repair or replacement. Inadequate fixing to parapet capping.

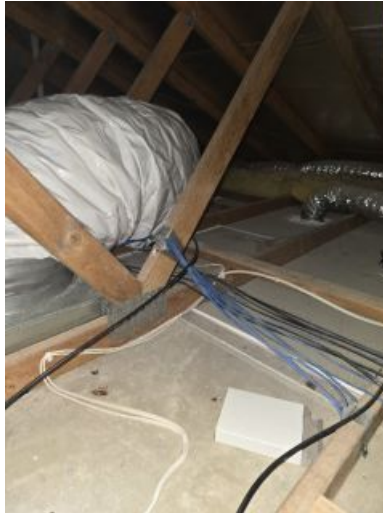
Insulation Status:

The insulation is out of place and should be re distributed correctly.

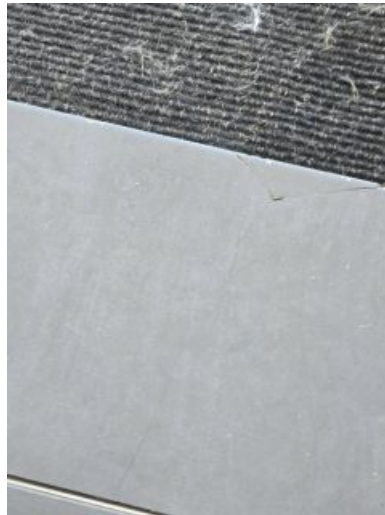
Entry/Foyer

<i>Room Location</i>	Front.
<i>Restrictions</i>	Inspection within this room was restricted by stored goods.
<i>Ceiling Condition</i>	The condition of the ceilings is generally fair.
<i>Walls Condition</i>	The condition of the walls is generally fair.
<i>Doors Condition</i>	The condition of the doors is generally fair.
<i>Floors Condition</i>	The condition of the floors is generally fair. Cracking is evident to some floor tiles.

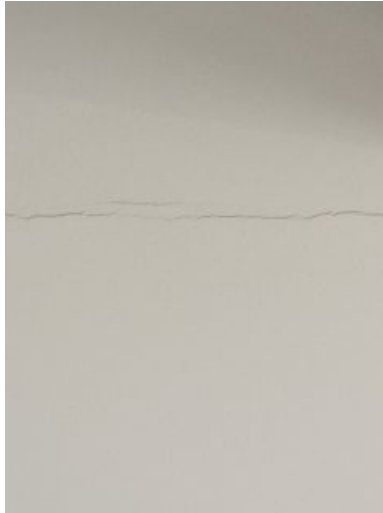
Hall

<i>Room Location</i>	Upstairs.
<i>Ceiling Condition</i>	The condition of the ceilings is generally fair. Minor settlement cracks were noted and is typical of this type of material. Crack opening width greater than 1.0mm<w<5.0mm. Periodic maintenance may be required.

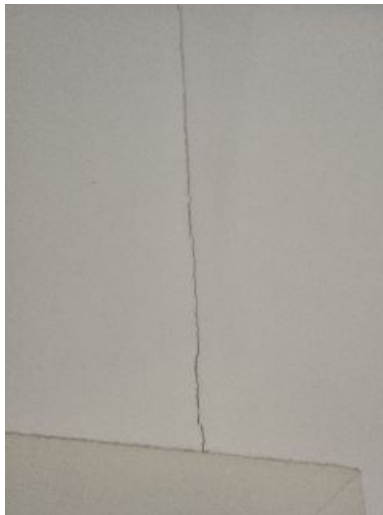
Walls Condition The condition of the walls is generally fair. Minor settlement cracks in walls. Crack opening width greater than 1.0mm <math>w < 5.0\text{mm}</math>. Periodic maintenance may be required.

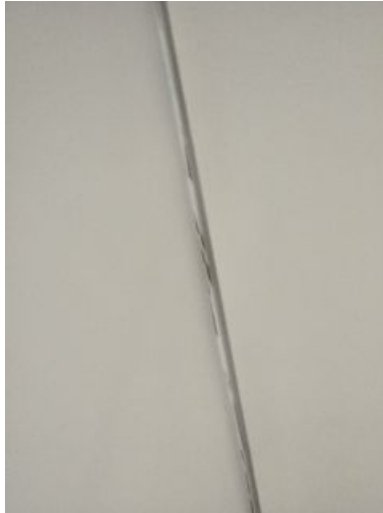
Dining Room

- Room Location** Rear.
- Restrictions** Inspection within this room was restricted by stored goods.
- Ceiling Condition** The condition of the ceilings is generally fair. Poor joint setting was noted to ceiling lining. Repairs are required to ceiling linings.

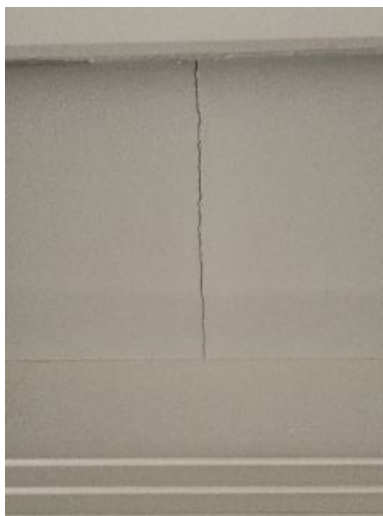
Family/Rumpus Room

<i>Room Location</i>	Upstairs.
<i>Ceiling Condition</i>	The condition of the ceilings is generally fair.
<i>Walls Condition</i>	The condition of the walls is generally fair. Minor settlement cracks in walls. Crack opening width greater than 1.0mm<w<5.0mm. Periodic maintenance may be required.

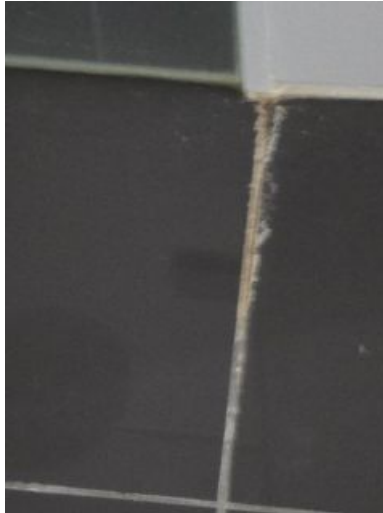
Ensuite Bathroom

<i>Room Location</i>	Main bedroom en suite.
<i>Restrictions</i>	Inspection within this room was restricted by stored goods.
<i>Ceiling Condition</i>	The condition of the ceilings is generally fair.
<i>Walls Condition</i>	The condition of the walls is generally fair.
<i>Windows Condition</i>	The condition of the windows is generally fair.
<i>Doors Condition</i>	The condition of the doors is generally fair.
<i>Floors Condition</i>	The condition of the floors is generally fair.
<i>Shower/Bath Condition</i>	The shower recess was tested and there was no visible water penetration to surrounding areas. IMPORTANT NOTE: This test may not reveal water leaks until the shower is put into constant use and surrounding areas monitored over a period of time. Silicone sealant has been applied to the interface of the floor and walls in the shower recess in an apparent attempt to prevent water penetration to surrounding areas. This method of repair can only be considered to be temporary.

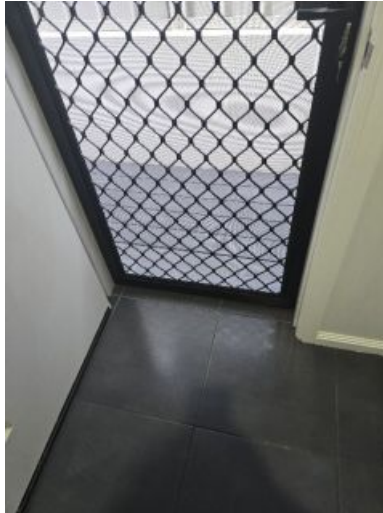
Laundry

<i>General condition of area</i>	This area is generally in fair condition.
<i>Room Location</i>	Rear.
<i>Restrictions</i>	Inspection within this room was restricted by stored goods.
<i>Ceiling Condition</i>	The condition of the ceilings is generally fair.
<i>Walls Condition</i>	The condition of the walls is generally fair.
<i>Windows Condition</i>	The condition of the windows is generally fair.
<i>Doors Condition</i>	The condition of the doors is generally fair.
<i>Floors Condition</i>	The condition of the floors is generally fair. Inadequate stepdown to threshold resulting in potential water ingress.

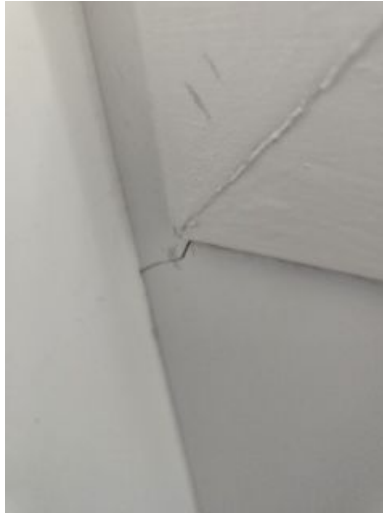
Toilet Two

<i>General condition of area</i>	This area is generally in fair condition.
<i>Room Location</i>	Adjacent to the bathroom.
<i>Ceiling Condition</i>	The condition of the ceilings is generally fair.
<i>Walls Condition</i>	The condition of the walls is generally fair.
<i>Windows Condition</i>	The condition of the windows is generally fair.
<i>Doors Condition</i>	The condition of the doors is generally fair.
<i>Floors Condition</i>	The condition of the floors is generally fair.
<i>Toilet Condition</i>	Appears serviceable.
<i>Tiles</i>	The condition of the tiles is generally fair. Some cracked tiles were noted to this area.

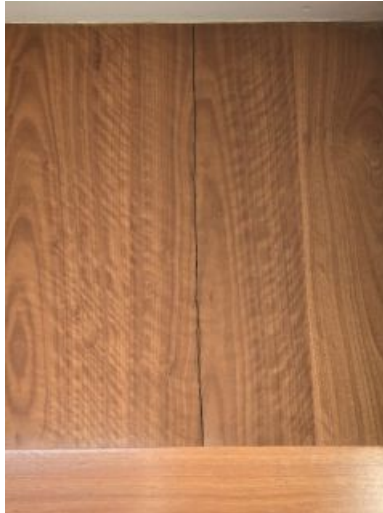
Stairs Internal

The stairs are constructed primarily from timber. The overall condition of the stairs is fair. Movement is evident to the stairs. This will require some minor maintenance.

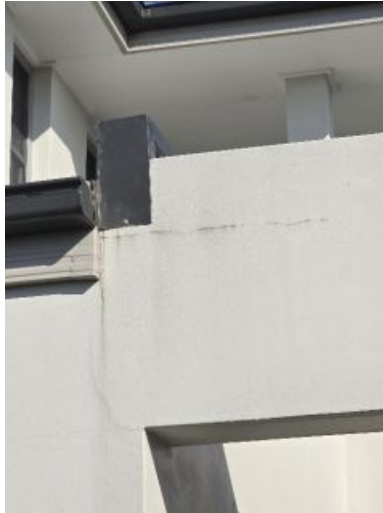
Position/Location: Rear elevation.

The condition of the walls is generally fair. Cracks are evident to brickwork or render. Visible evidence appears minor. Crack opening width greater than 1.0mm < w < 5.0mm. The area(s) where cracked brickwork or render was noted is listed below.

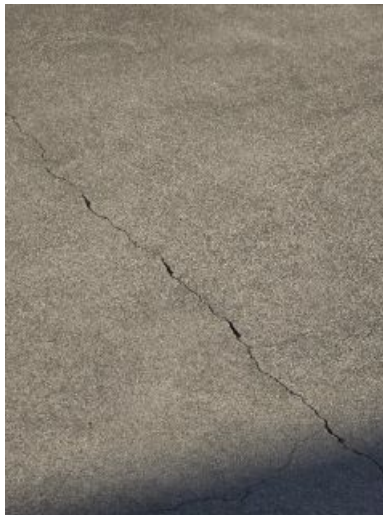
Driveway

Type & Condition: The concrete driveway stands in fair condition. The concrete driveway has some visible cracking that should be monitored for further movement.

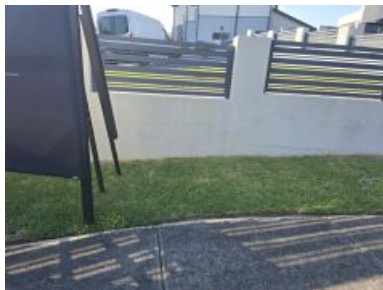
Fences & Gates

Fences Type & Condition: The fences are mainly constructed from metal. The fences are mainly constructed from brick. The fences are generally in fair condition and some repairs or maintenance is required. Repairs to fences are required. Minor cracking to masonry walls.

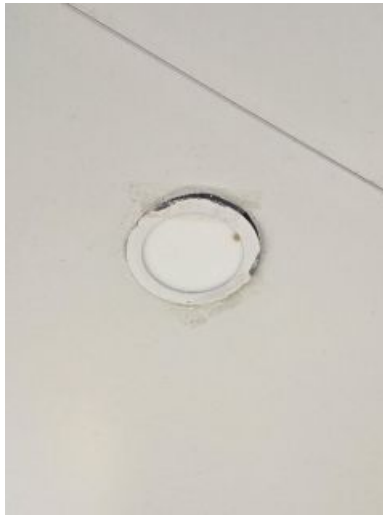
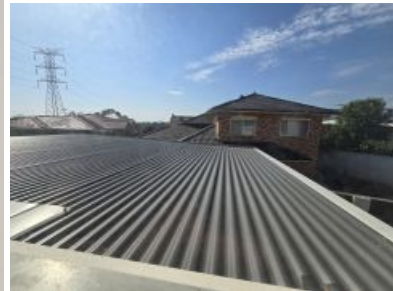
Deck

Defects or Maintenance Items Water ingress through light fittings noted. Roofing low pitch for material used may result in water leaks to ceiling.

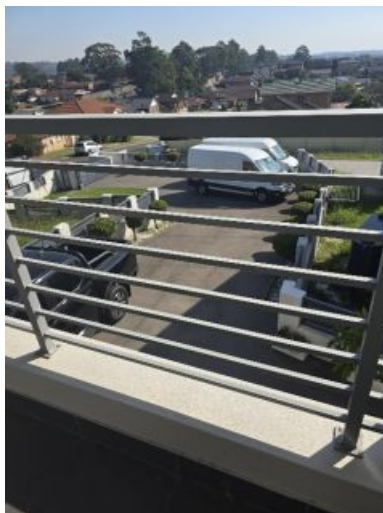
Position/Location: Front elevation.

Defects or Maintenance Items The balustrades either do not appear to comply with safety standards or could pose a safety hazard. The height of railings and spacing between railings should be checked to ensure that they comply. This must be further investigated and rectified as required.
