Visual Completion Building Inspection Report

Complies with Australian Standard AS 4349.1-2007

Property Inspected: Unit 5 / 1 Sample Avenue, Sydney

Inspection Date: 01 March 2024 - Report No. TG24030114

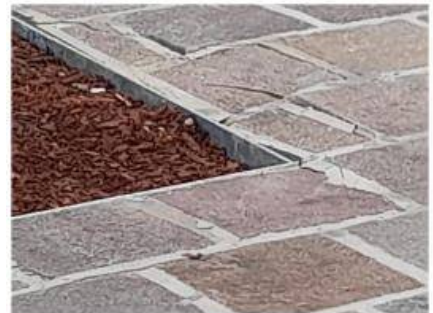
3. The paths/paved areas have some visible cracking and damaged areas may require repair and or replacement. The paved paths/paved areas have subsided in areas and will require repair and or relaying.

The paths/paved areas have some visible cracking and damaged areas may require repair and or replacement. The paved paths/paved areas have subsided in areas and will require repair and or relaying.

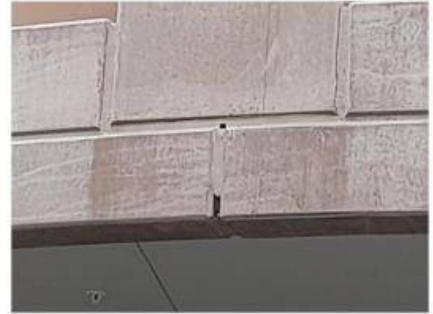
4. Expansion / articulation joints are not evident or installed to current standards. Recommend they be installed to allow for any movement of the building. Cracking of masonry may occur if not installed.

Expansion / articulation joints are not evident or installed to current standards. Recommend they be installed to allow for any movement of the building. Cracking of masonry may occur if not installed.

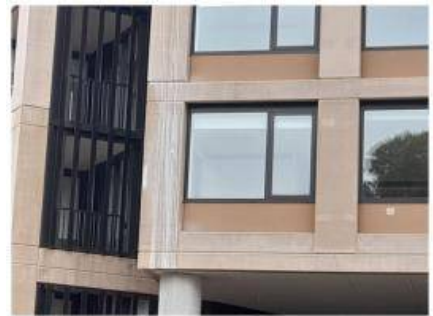
Some areas require cleaning.

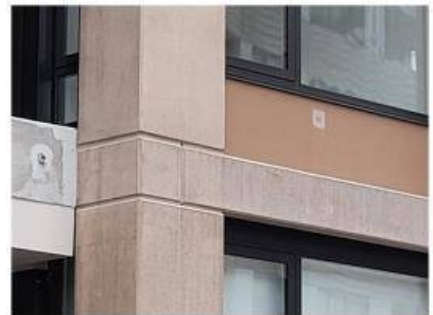
Painting is incomplete to some external wall areas. Rectification will be required.

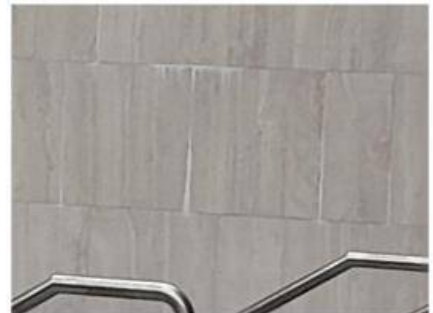
7. Efflorescence is noted to the face of masonry wall. Efflorescence is when white powdery deposit form on the surface of bricks, masonry or concrete caused by the crystallization and subsequent dehydration of soluble salts contained in the mortar or wall materials. Recommend the area be cleaned to remove efflorescence.

Efflorescence is noted to the face of masonry wall.
Efflorescence is when white powdery deposit form on the surface of bricks, masonry or concrete caused by the crystallization and subsequent dehydration of soluble salts contained in the mortar or wall materials. Recommend the area be cleaned to remove efflorescence.

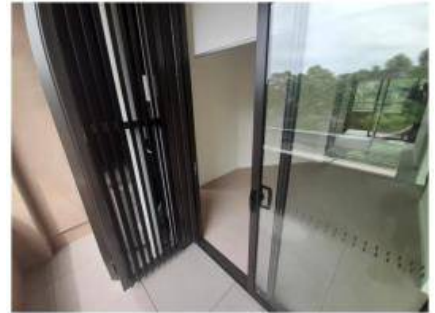
Insect screen door/s have not been provided and should be installed.

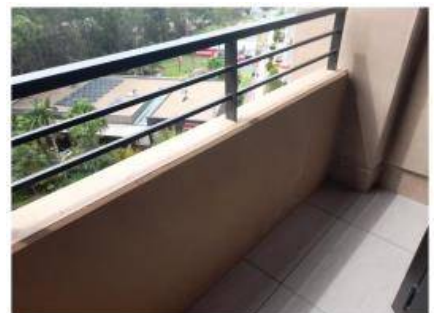
9. Railings are a natural ladder and may be hazardous. Recommend modifications be made to prevent injury.

Railings are a natural ladder and may be hazardous.
Recommend modifications be made to prevent injury.

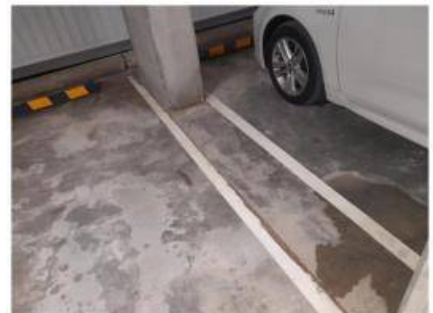
Base of some walls are below the external soil levels and are subject to lateral dampness or water entry. Additional waterproofing will be required or modifications will need to be made to lower moisture levels.

The external surface areas are higher than the internal garage floor allowing water to enter the area. Modifications and improvements to the external surface water drainage is required to prevent water entry.

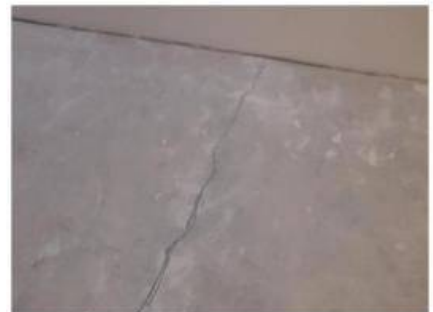
12. The concrete floor shows signs of moderate cracking. Please refer to section of this report - CRACKING OF BUILDING ELEMENTS for additional details.

The concrete floor shows signs of moderate cracking. Please refer to section of this report - CRACKING OF BUILDING ELEMENTS for additional details.

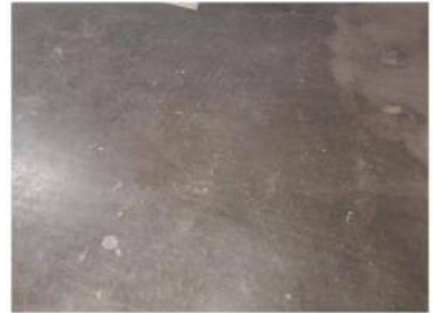
13. The concrete floor shows signs of minor cracking. Please refer to section of this report - CRACKING OF BUILDING ELEMENTS for additional details.

The concrete floor shows signs of minor cracking. Please refer to section of this report - CRACKING OF BUILDING ELEMENTS for additional details.

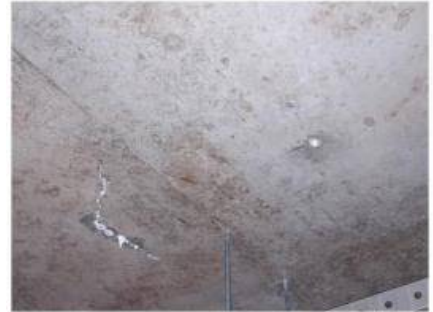
Cracking is present to the concrete ceiling. Cracking may allow water to enter the concrete, damage the steel reinforcement and cause concrete spalling. Damaged areas should be repaired. Please refer to section of this report - CRACKING OF BUILDING ELEMENTS for additional details.

There was evidence of water penetration through the ceiling and this area will require repair. Leaks appear to be from the above units and/or common areas. Waterproofing or plumbing repairs may be required and the Strata/Body Corporate should be notified to arrange the required repairs.

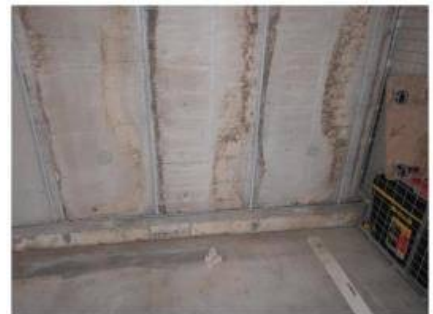
Rising damp is evident to the base of some or all masonry walls. Damp proof coursing material may not be installed, have been bridged or should be replaced. Quotations should be obtained from a suitably qualified contractor to rectify damp areas. Cost to replace damp proof coursing material can range upwards from \$250.00 per linear metre excluding re-instatement of wall finishes. Evidence of lateral damp was noted. This may be the result of a cavity bridge, plumbing leak or other undetected defect. This situation should be rectified.

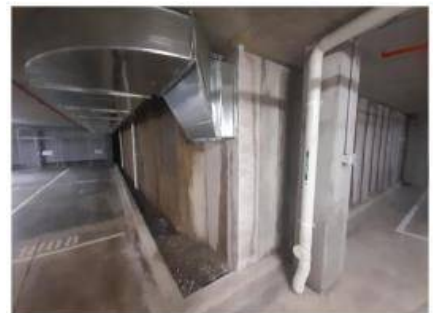
Falling damp noted. This could be due to defective roofing, roof flashings or faulty waterproofing membrane. Repair or replacement will be required to prevent further water entry.

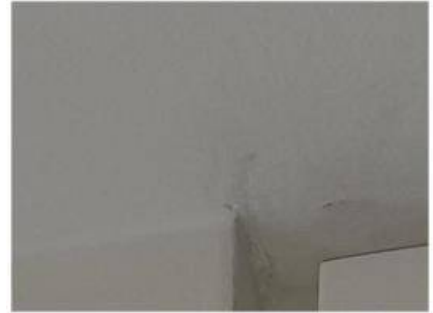
Defective or poor surfaces were noted to ceiling materials. Rectification is necessary.

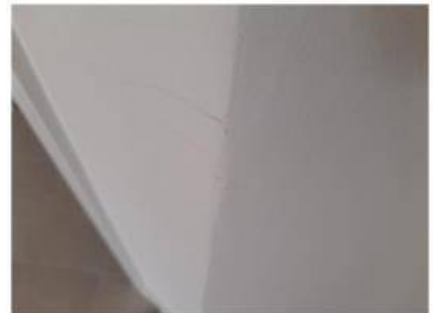
Minor repairs and paint touch ups are required. Rectification is necessary.

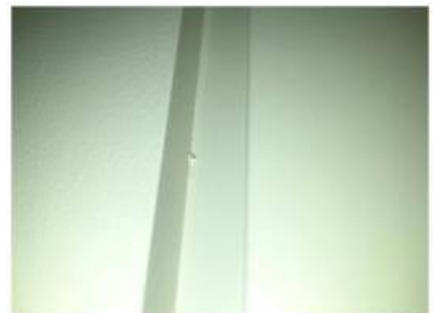
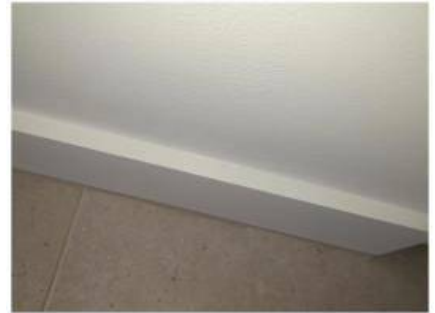
Minor repairs and paint touch ups are required. Rectification is necessary.

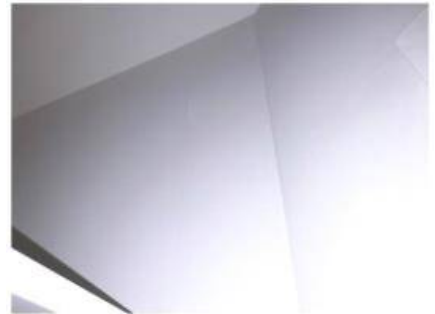
Minor repairs and paint touch ups are required. Rectification is necessary.

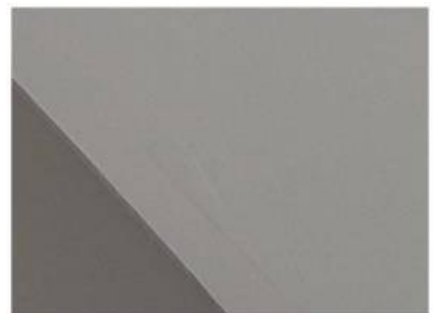
Defective or poor surfaces were noted to ceiling materials. Rectification is necessary.

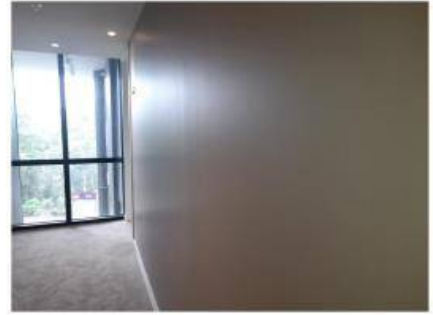
Defective or poor surfaces were noted to some sections of the wall materials and repairs are required. Rectification is necessary.

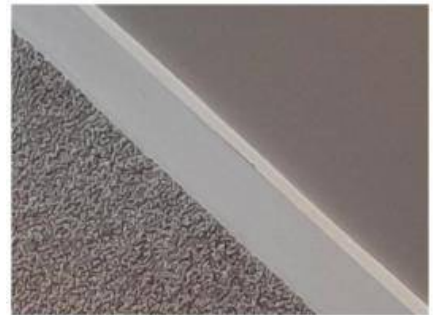
Minor repairs and paint touch ups are required. Rectification is necessary.

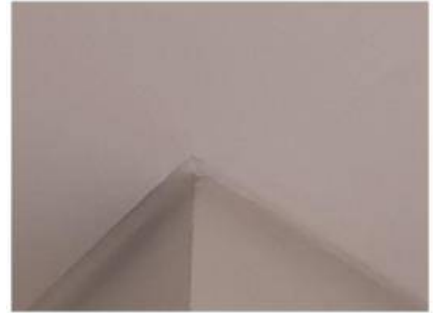
Defective or poor surfaces were noted to ceiling materials. Rectification is necessary.

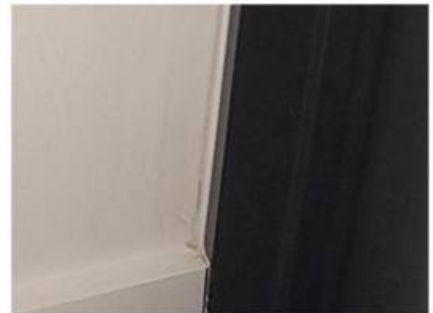
Minor repairs and paint touch ups are required. Rectification is necessary.

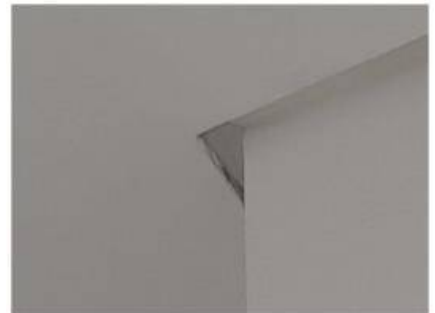
Minor repairs and paint touch ups are required. Rectification is necessary.

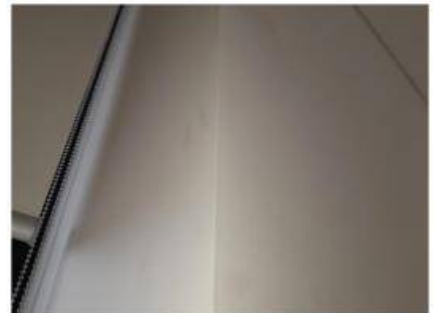
Minor repairs and paint touch ups are required. Rectification is necessary.

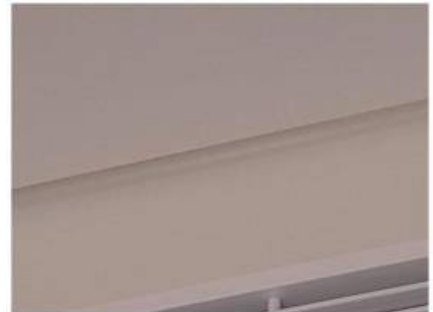
Painting is not complete, appears transparent and requires rectification to provide a suitable finish.

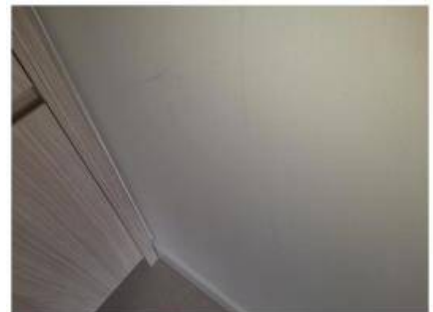
Minor repairs and paint touch ups are required. Rectification is necessary.

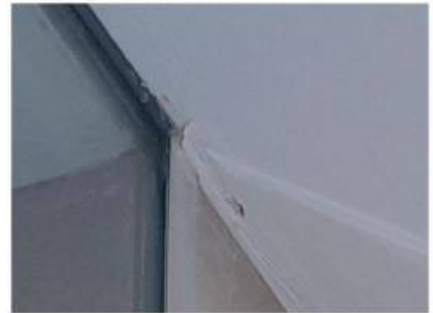
Minor repairs and paint touch ups are required. Rectification is necessary.

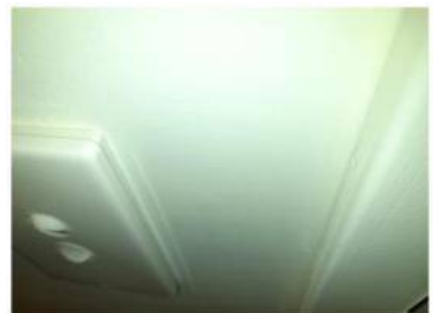
Defective or poor surfaces were noted to some sections of the wall materials and repairs are required. Rectification is necessary.

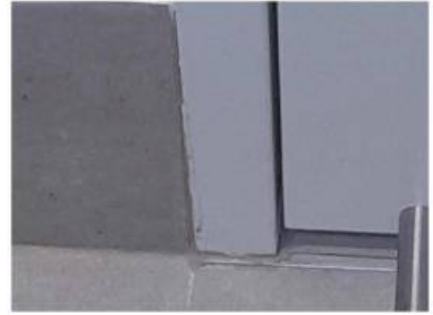
The condition of the door hardware is generally acceptable. Minor paint touch ups to metal jambs are required. Rectification is necessary.

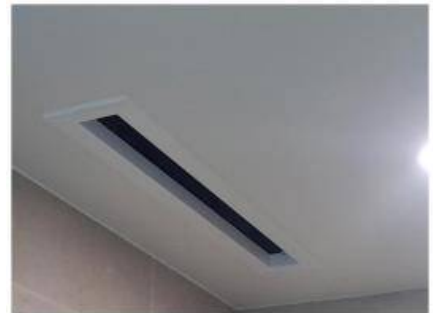
We recommend a cover be installed to sealing exhaust fan.

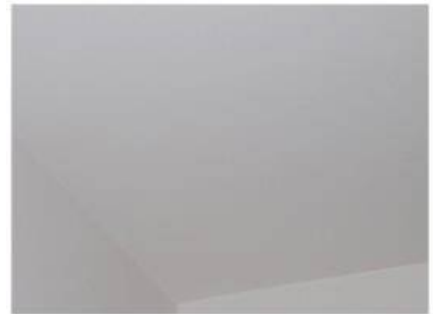
Defective or poor surfaces were noted to ceiling materials. Rectification is necessary.

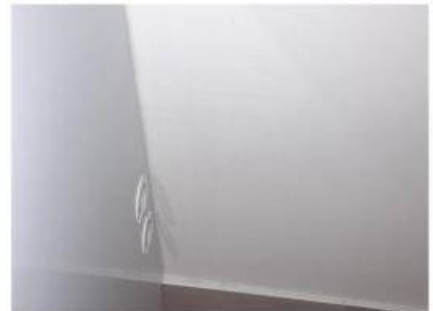
Defective or poor surfaces were noted to some sections of the wall materials and repairs are required. Rectification is necessary.

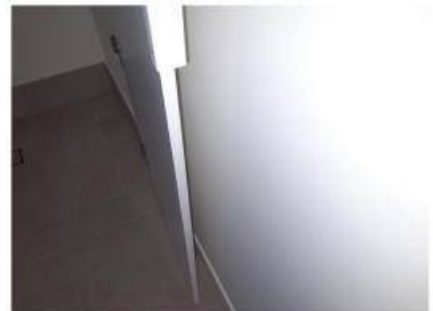
The condition of the door hardware is generally acceptable. Recommend that the installation of door stops be provided to all of the doors.
