## Timber Pest Inspection Report

**Property Inspected: 14 Sample Street, Sydney**

COMMISSIONED BY:	Rose Kanaan & Associates.
REPORT NUMBER:	EDENMATA140324P.
DATE OF INSPECTION:	14.03.2024.
PURCHASER	Mr Elmedin & Mrs Senka .
VENDOR	Sample.
INSPECTOR:	Steve BBCM UNSW.
PROPERTY ADDRESS:	14 Sample Street, Sydney.

A visual Pre- Purchase Pest Inspection in accordance with Australian Standard AS4349.3

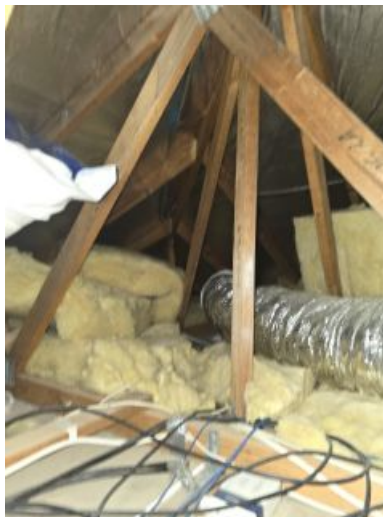
*Inspection Restrictions* Insulation is present in the roof cavity. This restricted inspection to some roofing timbers. Removal of insulation is not within the scope of a standard visual timber pest inspection report however, this would be necessary for a more complete report to be submitted.

Sarking paper covered tile battens restricting inspection.

Ducting associated with air-conditioning or heating restricted inspection.

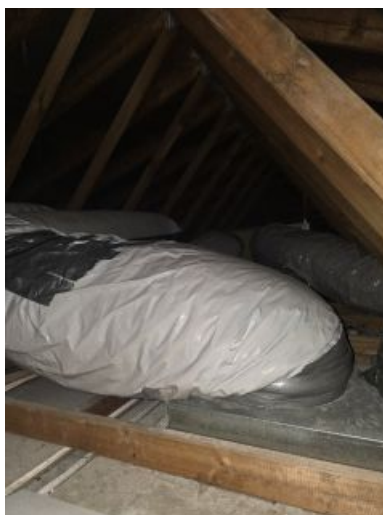
*Details* No Timber Pest activity was detected to visible and accessible timbers at the time of the inspection.

It should be noted that inspection within this area was limited as noted. This comment regarding the absence of evidence of Timber Pest activity refers to the accessible inspected areas and timbers only.

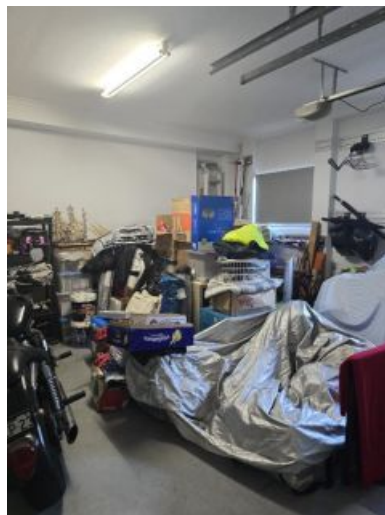
Stored items restricted inspection to the interior of the garage.
