Visual Building Inspection Report

Commissioned By: Sample Legal & Associates

Property Inspected: 14 Sample Street, Sydney

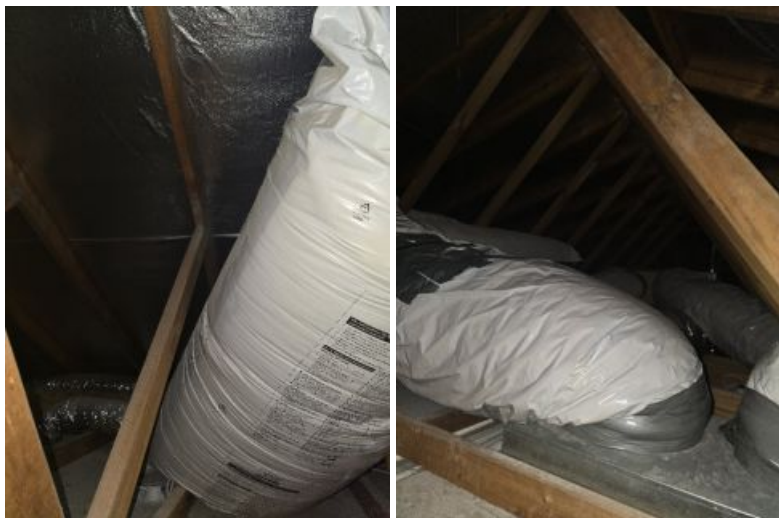
Insulation is present in the roof cavity. This restricted inspection to some roofing timbers. Removal of insulation is not within the scope of a standard visual inspection report. Sarking membrane covered tile battens restricting inspection. Ducting associated with airconditioning or heating restricted inspection.

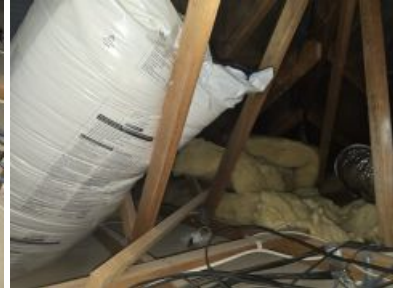
The insulation is out of place and should be re distributed correctly.

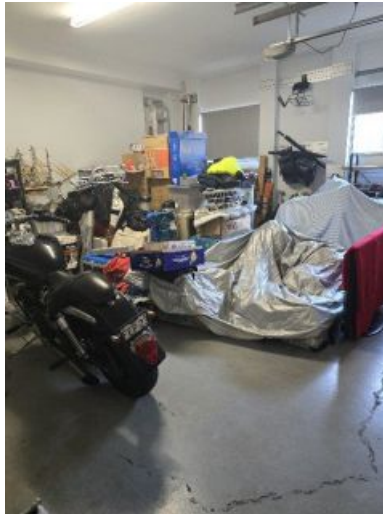
<i>Garage Location</i>	Under the main building.
<i>Restrictions to inspection</i>	Stored items restricted inspection to the interior.

<i>Wall Construction</i>	Brick veneer:
<i>Wall Condition</i>	The condition of the walls is generally fair.
<i>Front Doors - Type & Condition</i>	The main garage door is a panel lift style door and is in fair condition.
<i>Floor - Type & Condition</i>	The concrete floor is generally in fair condition.
<i>Ceiling Condition</i>	The condition of the ceilings is generally fair.
<i>Gutters and Downpipes</i>	Appear to be in serviceable condition.
<i>Eaves Type & Condition:</i>	The eaves are lined with fibre cement sheeting. The overall condition of the eaves lining is fair.
<i>Fascias & Bargeboards Type & Condition:</i>	The overall condition of the fascias/bargeboards is fair.
<i>Lintels - Type & Condition</i>	The condition of the lintels is generally fair.
